*First Flight  
Home Inspections, Inc.*

**HOME INSPECTION REPORT**

Inspected Property Address:  
1234 Sample Drive  
Anytown, NC 27000

Field Inspection Performed on Monday, April 02, 2012 January 1, 2012 Time: 9:00  
Type of Inspection: Pre-Purchase Report # 00000-0

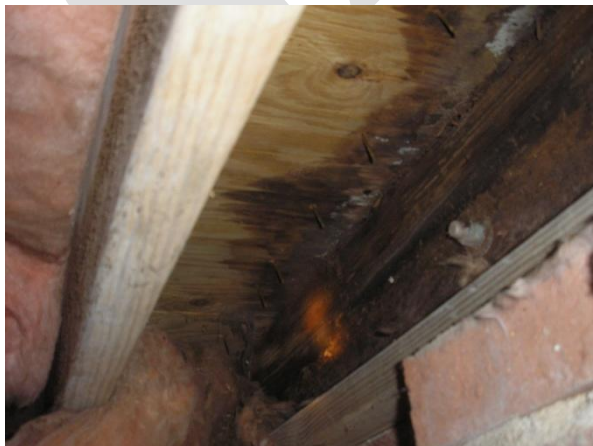
1. The wood sub floor and wood band joist in the crawlspace along the area of the rear entryway door and rear deck are water stained and water damaged. Water penetration into the building envelope can result in structural damage and undesirable environmental conditions.

This concern requires repair. It is recommended that this concern be evaluated to determine the extent of, or cause of the problem and addressed/repared as necessary by a qualified professional general contractor experienced in residential structures.

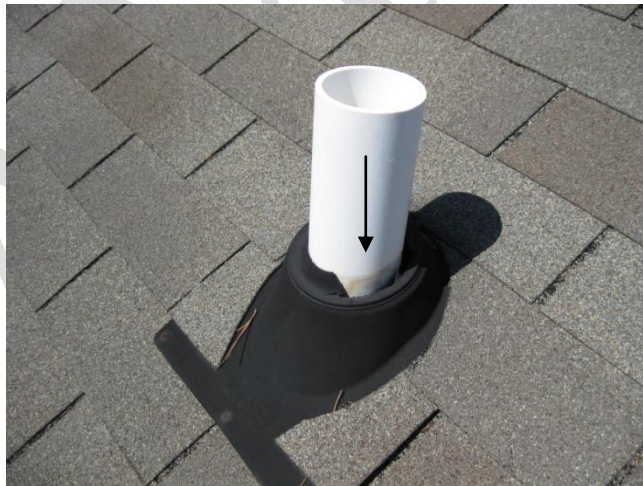
3. The rubber boot flashing for the DWV vent pipe on the rear roof is deteriorated with an approximately two square inch opening. Water penetration into the building envelope can result in structural damage and undesirable environmental conditions. This is above the area of the master bathroom ceiling that is water stained.

This concern requires repair. It is recommended that this concern be evaluated to determine the extent of, or cause of the problem and addressed/repared as necessary by a qualified professional contractor specializing in roofing.

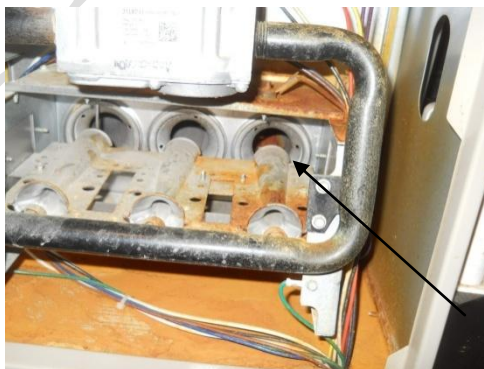
9. The right most burner section of the heat exchanger in the first floor HVAC furnace is rusted. This concern warrants further investigation by a specialist. It is recommended that this concern be evaluated to determine the extent of, or cause of the problem and addressed/repaired as necessary by a NC licensed heating contractor.

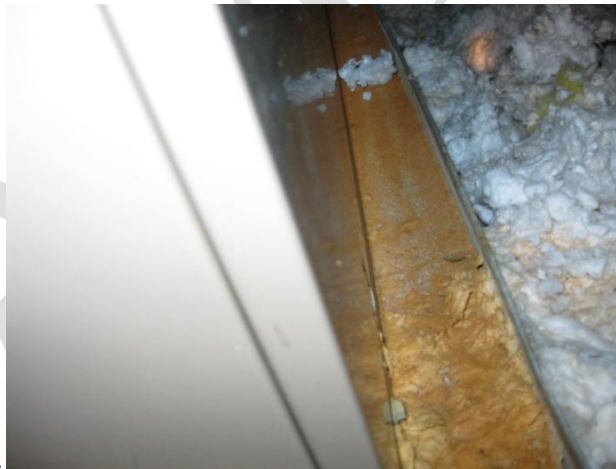
10. The pan under the HVAC unit in the attic is rusted and has a watermark from standing water. This is an indication of improper draining of condensate (water) from the AC evaporator

This concern warrants further investigation by a specialist. It is recommended that this concern be evaluated to determine the extent of, or cause of the problem and addressed/repaired as necessary by a NC licensed heating contractor.

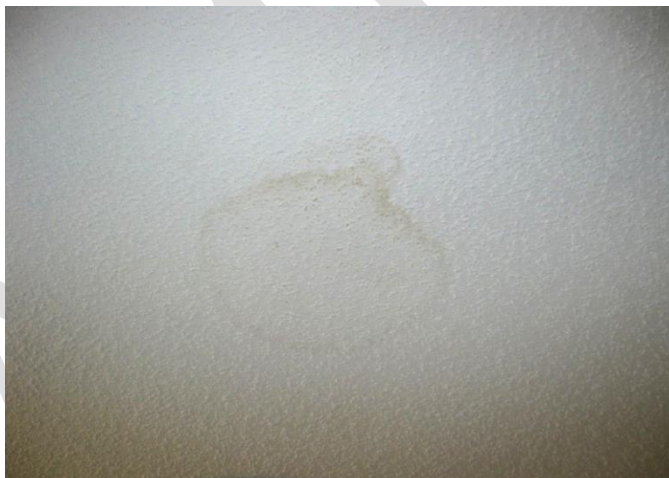
11. The ceiling in the master bathroom is water stained. This is below the area of the DWV vent pipe roof penetration in the rear attic.

This concern warrants further investigation by a specialist and requires repair. It is recommended that this concern be evaluated to determine the extent of, or cause of the problem and addressed/repared as necessary by a qualified professional general contractor experienced in interiors.
